# Manhole Inspection Summary

Manhole # S41GG\_008MH

**Location** Address: **REAR OF 1331 CAROLINE ST**

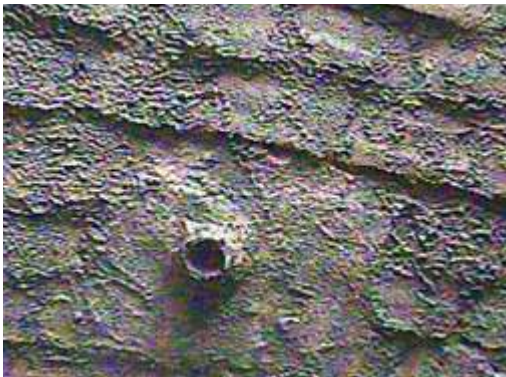
Comments **POSSIBLE ILLICIT CONNECTION - SEE PHOTO**

POSSIBLE ILLICIT CONNECTION

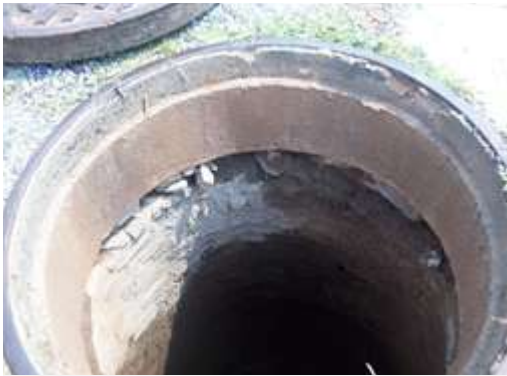
Defect 2

Condition: ☐ Sound ☒ **Cracked** ☐ Root Intrusion ☒ **Loose Brick** ☒ **Deteriorated**

deteriorated chimney

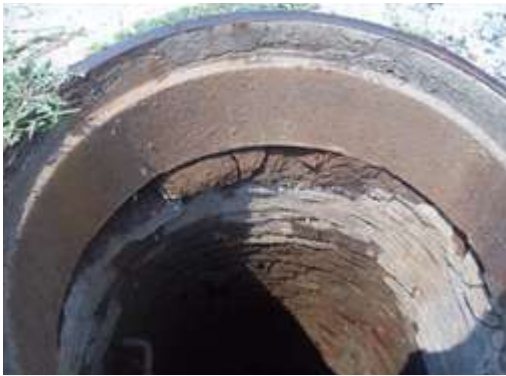
Defect 1

cracked chimney, loose bricks

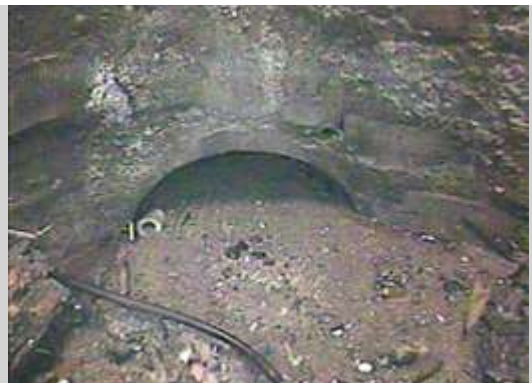
12 O'Clock Outflow

8 in. Circular Gravity Sewer  
Pipe Out @ 12 O'Clock

Deposits: ☐ None ☐ Mud ☐ Sludge ☒ **Debris** ☐ Grease

Silt Depth: **6** (in.) Deposits Extent: **Heavy**
